[Docket No. 92-CE-63-AD; Amendment 39-9251; AD 95-12-01]

Airworthiness Directives; Piper Aircraft Corporation PA-25 Series Airplanes

Appendix to AD 95-12-01—Procedures and Requirements for Wing Forward Spar Attachment Assembly; Inspection of Piper PA-25 Series Airplanes

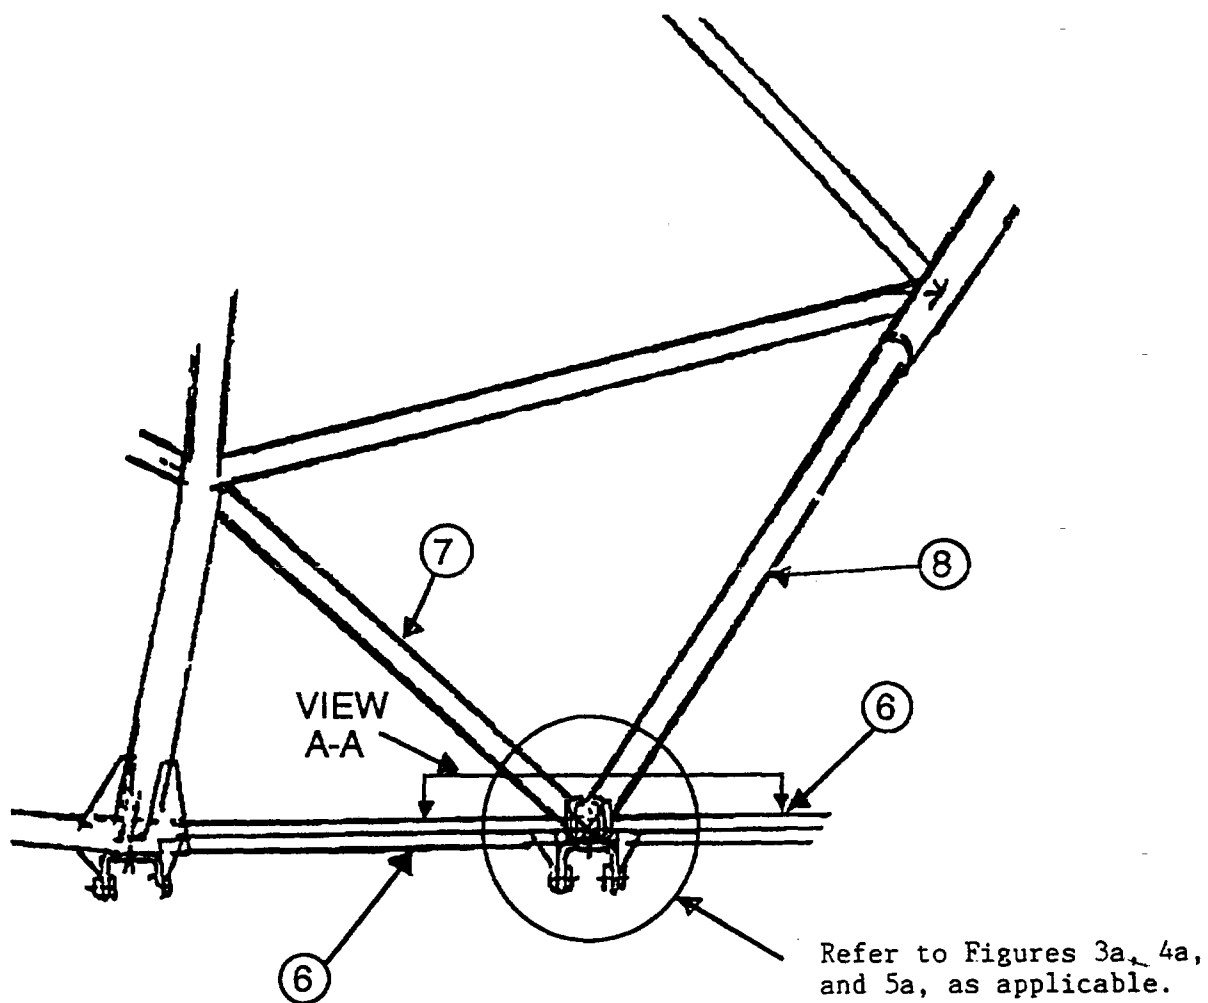
PA-25
Side View of the Front Wing Fitting
and Landing Gear Fittings

(a) Gain access to the left and right wing forward spar fuselage attach fittings by removing the screws retaining the wing fairing. Dismantle the wing fillet by removing the screws on the aft edge top and bottom and removing the wing fairing (see FIGURE 1 of the Appendix to this AD).
